MANAGEMENT OF AVIAN HUMERAL FRACTURES- A REPORT OF TWO CASES

SUMMARY

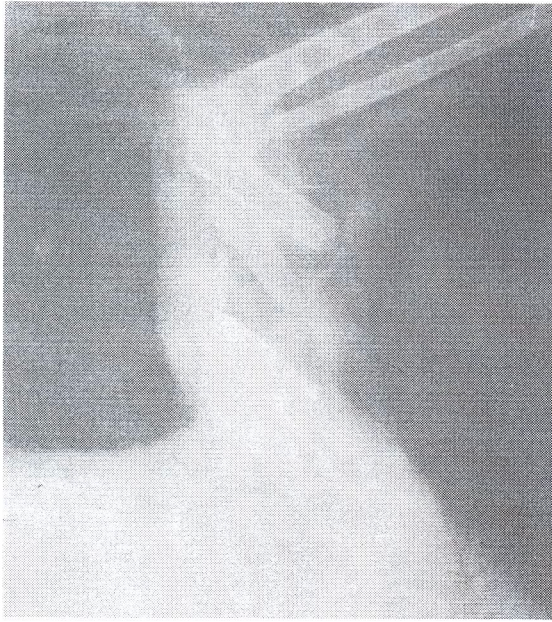
was reported to the wild life department and were asked to proceed for proper treatment. The broken wings were temporarily immobilized by supporting bandage and sent for X-ray examination. Radiograph showed multiple fracture of the mid shaft of the humerus (Fig 1).

Fig 1. Multiple mid shaft fracture of humerus

The birds were anaesthetized by injecting Ketamine @ 0.2 mg/kg body weight and were prepared for corrective surgery. Both the birds were secured in right lateral recumbency keeping the affected left wing upwards. The feathers were clipped and the operative area was shaved in the direction of root of the feathers avoiding any injury to the ridges. The humerus was approached from the craniolateral side. The bleeding was checked by the digital pressure. The extra pieces of the bone lying scattered in to the surrounding tissues were removed and a Steinmann pin mounted on Jacob chuck was placed in to the bone marrow cavity in a retrograde fashion. The extra pin was cut at the level of skin by a pin cutter. Ampicillin powder was sprinkled in to the separated tissue, and the muscles and skin were closed in a routine manner. The post-operative radiograph revealed good

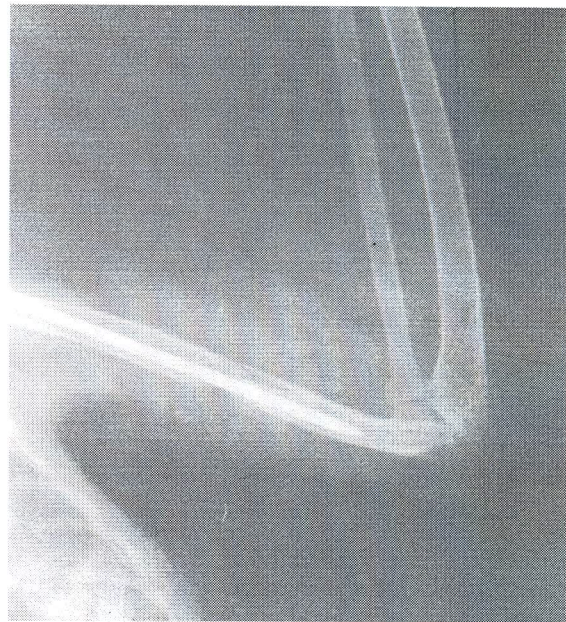
Fig 2. Post-operative radiograph showing healing of fractured bone after 4th week

Post-operatively, the birds were administered ampicillin @10 mg/kg body weight (bid i/m), phenyl butazone (3 ml, i/m) and vitamin B-complex (2 ml, i/m) up to 5 days. Daily antiseptic dressing of the wound with povidone-iodine was done. Both the birds started lifting the repaired wing and taking food and water. The peacock was handed over to the wild life department, while, the duck was taken by the military personnel. The sutures were removed after ten days. The duck started using the wing after 4th week of the repair and radiograph showed healing of the fractured bone (Fig 2). The pin was removed after 6th week of the repair and the bird was kept in captivity for another two weeks and left loose afterward. The follow up of the peacock was not available. After 10th week of the repair it was reported that the duck is using the wing without any problem.
